# Manhole Inspection Summary

Manhole # S15CC1026MH

**Location** Address: **3717 PARK HEIGHTS AVE**

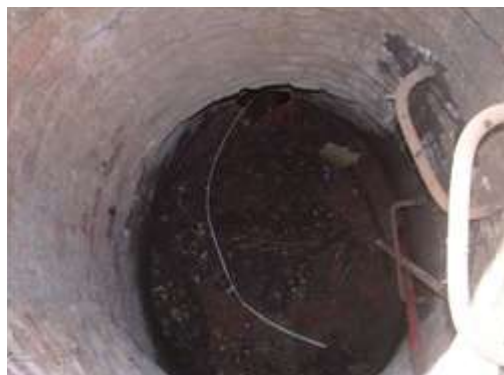
Top View

Adjustment, Corbel and Barrel infiltration.  
Channel debris.

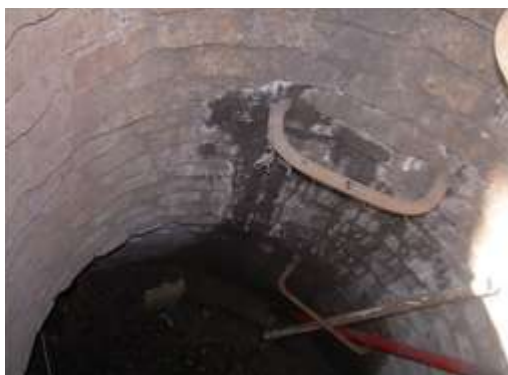
Defect

Adjustment, Corbel and Barrel infiltration.

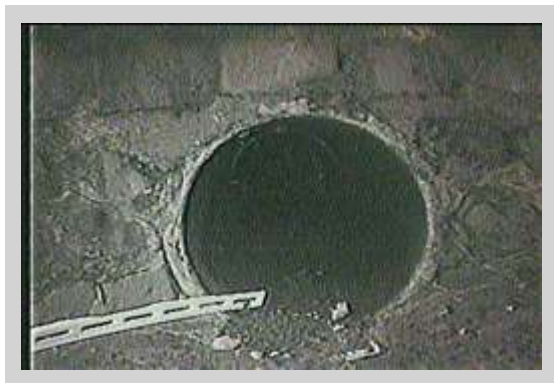
Pipe Out @ 12 O'Clock

Infiltration: **Evidence**

Pipe Seal Cond: **Cracked**
